Goatstown Development – Ground Investigation

Client: Orchid Residential Ltd.

Report No.: 20-0013

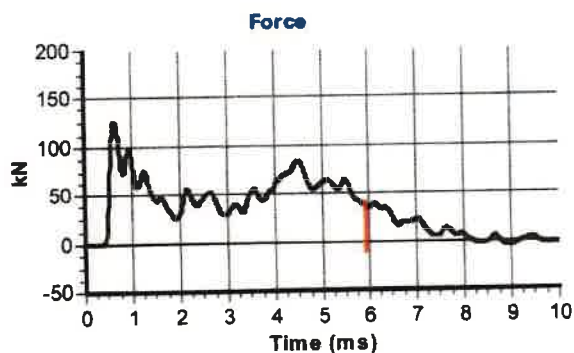
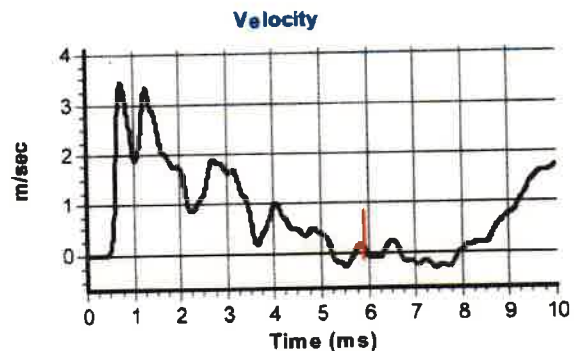
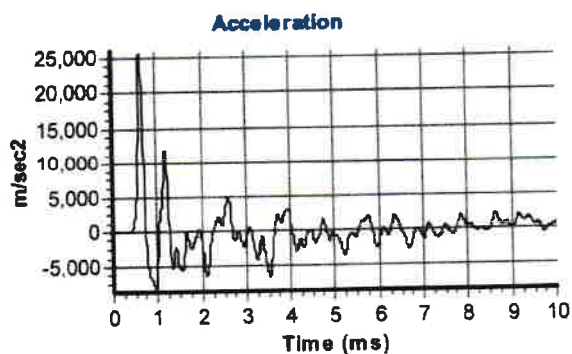
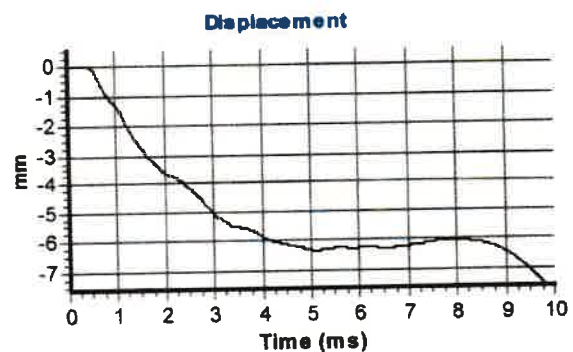
Area of Rod A (mm^2): 905
Theoretical Energy E_{theor} (J): 473
Measured Energy E_{meas} (J): 360
